G. & G. SURVEY	L. & A.	OCT 1 1927	Acc. No.
G. & G. SURVEY					
L. & A.					
OCT 1 1927					
Acc. No.					
State: Washington					
DESCRIPTIVE REPORT					
Topographic Hydrographic	Sheet No. 4657				
LOCALITY					
Puget Sound					
Everett					
1927					
CHIEF OF PARTY					
G. C. Jones

EVERETT, WASHINGTON

Report on Hydrographic Sheet No. 4657

Report on Hydrographic Sheet No. 4657 (Additional Work 1928)

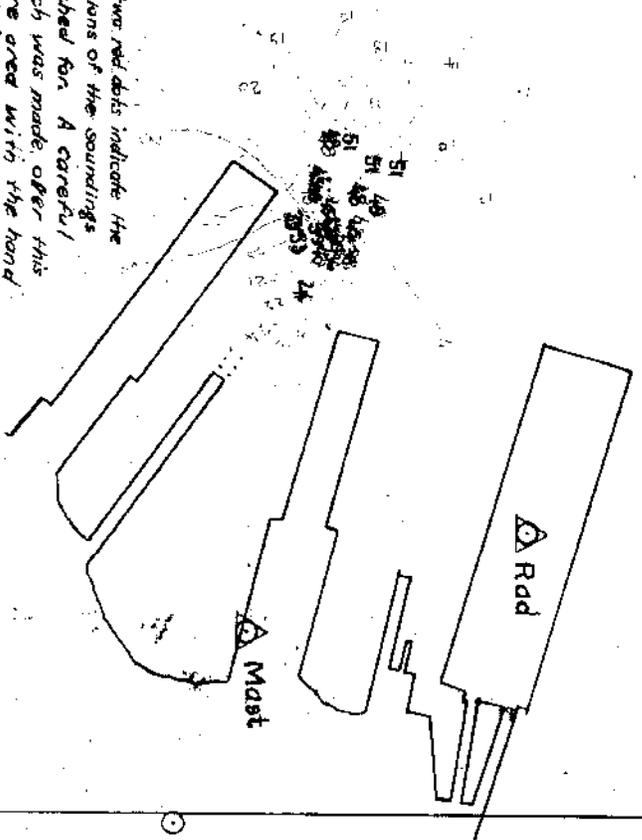
H. 4657

The two red dots indicate the positions of the soundings searched for. A careful search was made over this entire area with the hand lead from a staff. Only the shallowest soundings were located.

Showing soundings made on April 20, 1928 according to the instructions of April 9, 1928 to supplement Sheet No 4657 of Everett Harbor.
