## DESCRIPTIVE REPORT

*Type of Survey* ..... HYDROGRAPHIC

*General Locality* ..... West Coast of Oahu

*Sublocality* ..... Kepuhi Point to Barbers Point

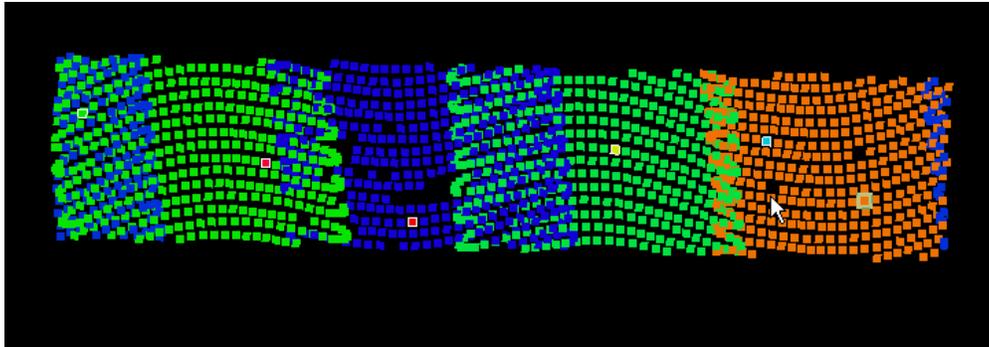
**Figure 2.** A subset of Lidar data colored by line from survey W00079 shown in Fledermaus 3D Editor. Survey W00079 did not meet data redundancy requirements of 200 percent coverage for Lidar data, as seen above. This results in a decrease in object detection capability. <sup>1</sup>

<sup>1</sup> Concur with clarification, although survey W00079 does not meet IHO order 1 specifications, it appears that the survey is adequate to supersede the current charted information except where noted in this report or drawn in green on the HDrawing.

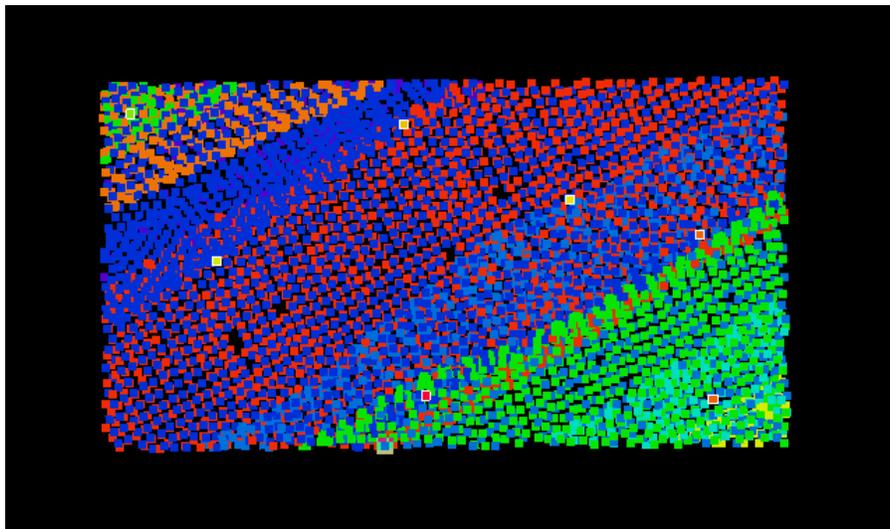
**Figure 3.** An example of 200 percent Lidar coverage from Survey W00080. All surveys aside from W00079 achieved 200 percent data redundancy in areas surveyed with the SHOALS Lidar system. <sup>2</sup>

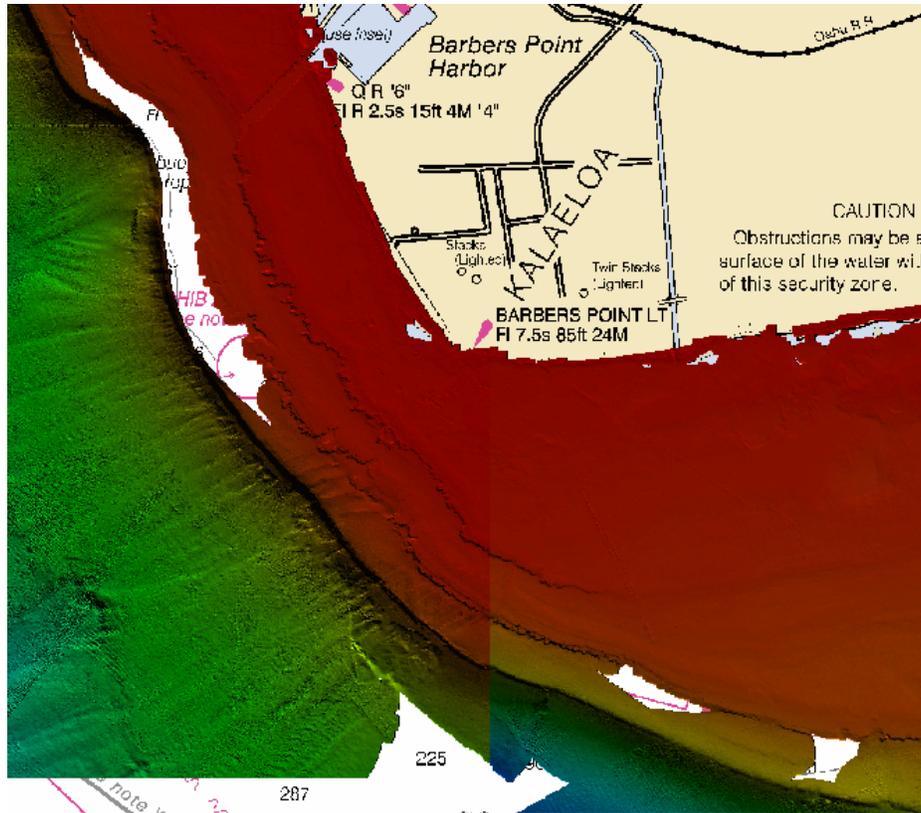
**Figure 4.** Gaps in data coverage are visible in the DTMs for surveys W00079, W00080 and W00081. The gaps occurred along the junction between multibeam and Lidar data where coverage does not overlap. <sup>3</sup>

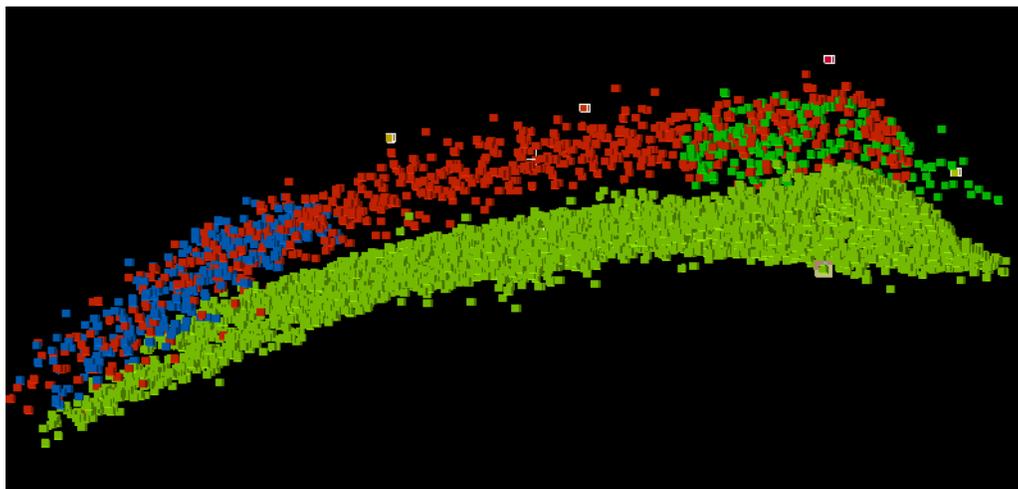
**Figure 5.** A vertical offset between Lidar and multibeam survey lines from survey W00079 is displayed in Fledermaus 3D Editor. The multibeam data was primarily deeper than the lidar data. <sup>4</sup>

Soundings are colored by survey line with the lidar depths displayed in blue, red and green and the multibeam depths in the olive green.

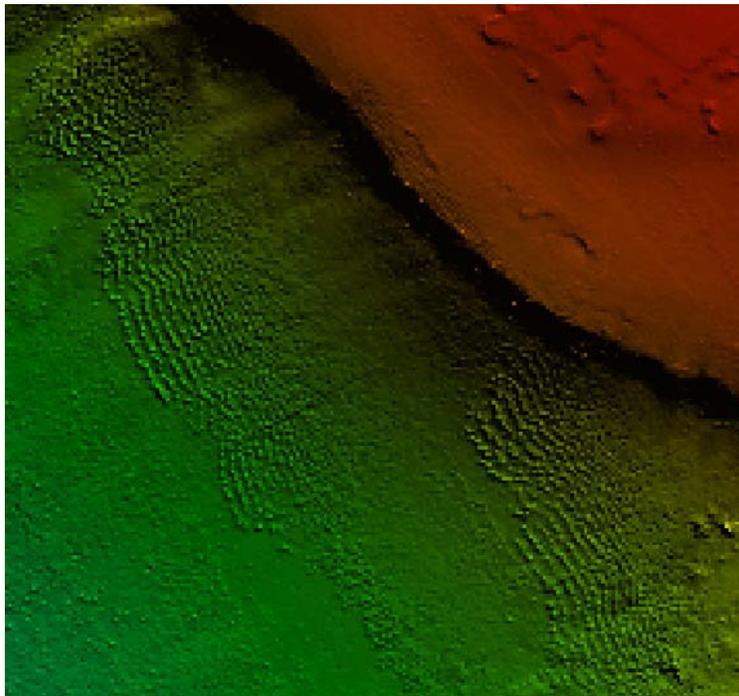
**Figure 6.** Systematic artifacts resulting from sparse data density in outer beams of the EM 3000 multibeam system. The artifact was particularly pronounced when surveying on steep slopes and in water depths greater than 200 meters.

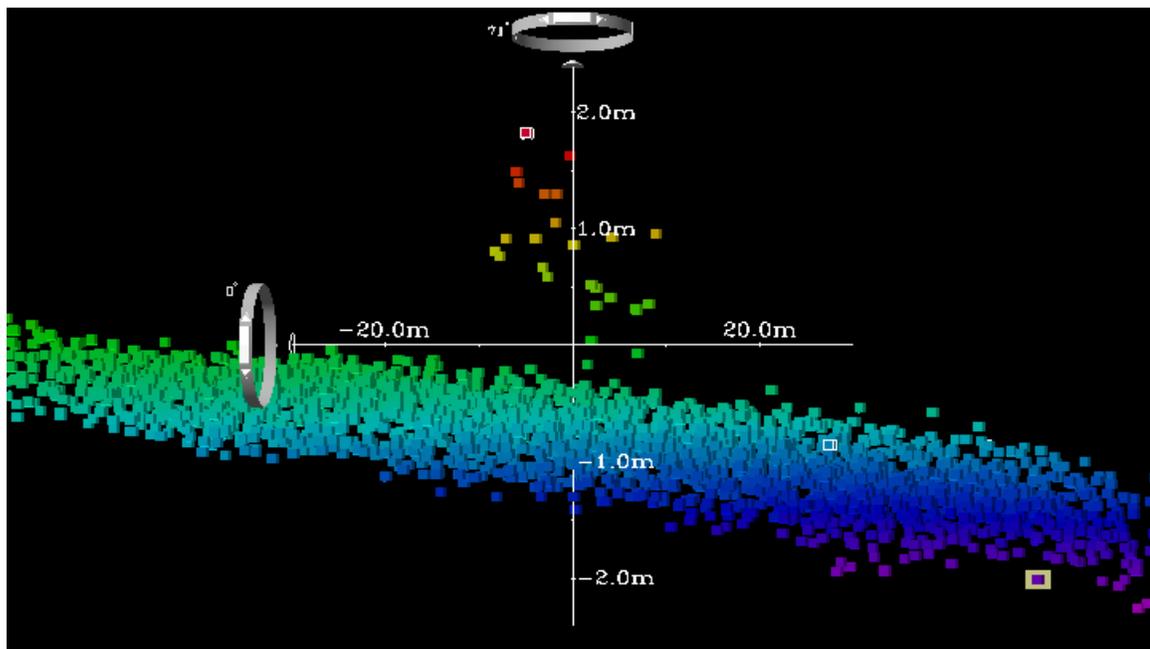
- A. The first obstruction was located at 21/16/18.89 N, 158/05/11.18 W with a least depth of 22.92 meters, rising approximately 2 meters above the ocean floor. According to a “Note” on chart 19357 it is located in the vicinity of Fish Aggregating Devices (FADs). It was visible in Fledermaus 3D Editor (Figure 8).<sup>8</sup>

*Figure 8.* Reported obstruction shown in Fledermaus 3D Editor with soundings colored by depth.

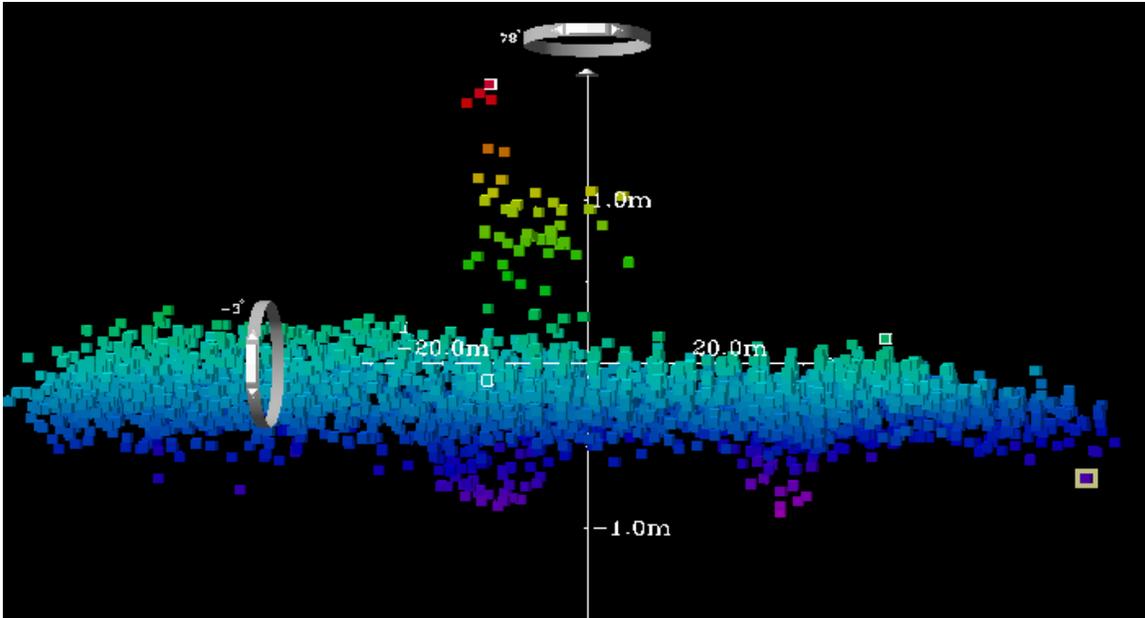
- B. The second obstruction reported by NAVOCEANO was located at 21/17/23.67 N, 158/02/00.72 W (Figure 9). It appears to be the true position of the charted (19357) PA wreck located approximately 400 meters to the southwest (21/17/08 N, 158/02/00 W). The potential wreck has a least depth of 5.3 fm (9.7 m) and is located in the vicinity of charted 6.5 fm sounding.<sup>9</sup>

**Figure 9.** Potential wreck displayed in Fledermaus 3D Editor with soundings colored by depth. The obstruction is most likely the true position of a charted (19357) PA wreck positioned 400 meters to the southwest.

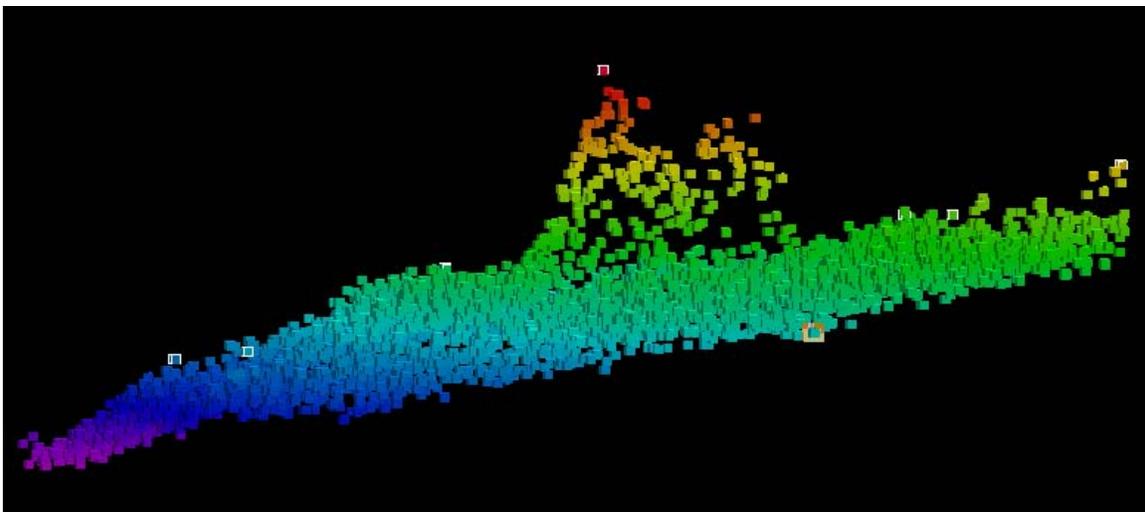
- C. A new obstruction, potentially a small wreck, was reported by NAVOCEANO at 21°17'17.74 N, 158°03'33.47 W with a least depth of 6 ¾ fm (12.6 m). The obstruction was visible in Fledermaus 3D Editor (Figure 10).<sup>10</sup>

**Figure 10.** Potential new wreck displayed in Fledermaus 3D Editor. Soundings are colored by depth.

<sup>10</sup> Concur with clarification, until this feature is identified as a wreck it is recommended that this features be charted as a 6 ¾ fathom Obstruction at the survey position.

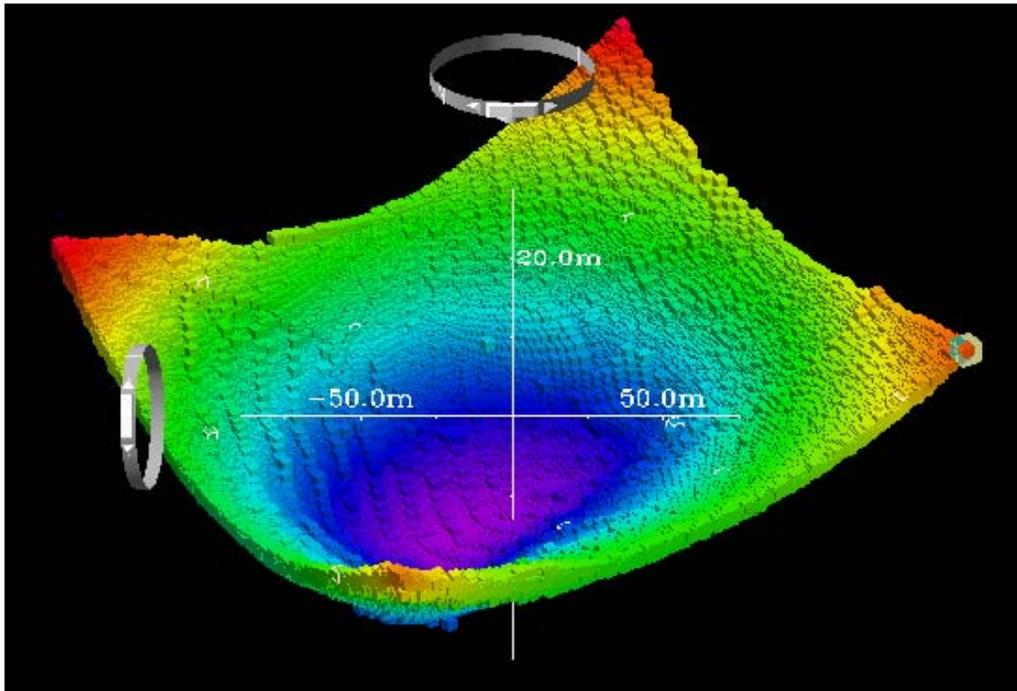
E. A sink hole was located at 21-16-08.72 N, 158-2-06.67 W. Depths were surveyed at approximately 50 fm (92 m) in the vicinity of charted 23 and 24 fm soundings (Figure 11). <sup>13</sup>

*Figure 11.* New sink hole displayed in Fledermaus 3D Editor with soundings colored by depth.

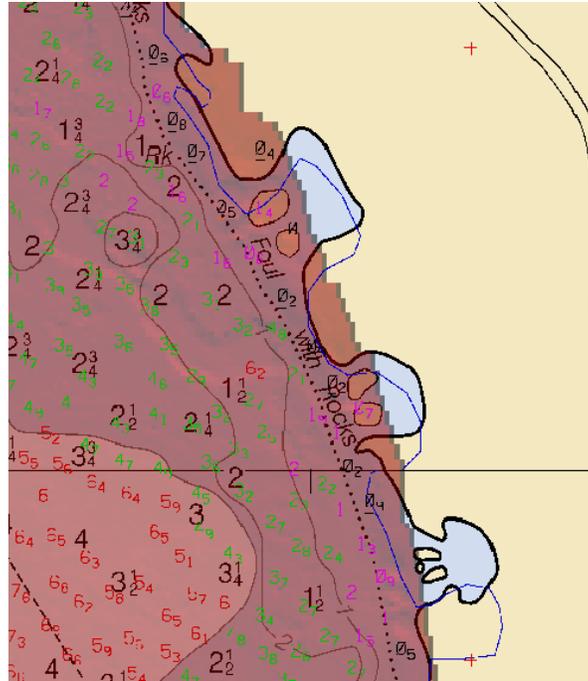
Figure 14. Offset between MHW from W00081 smooth sheet represented by the blue line and the charted (19362) coastline. 18

<sup>18</sup> The source of the shoreline on the Navy smooth sheets is unknown. It is recommended that MCD use the most up to date RSD shoreline possible.

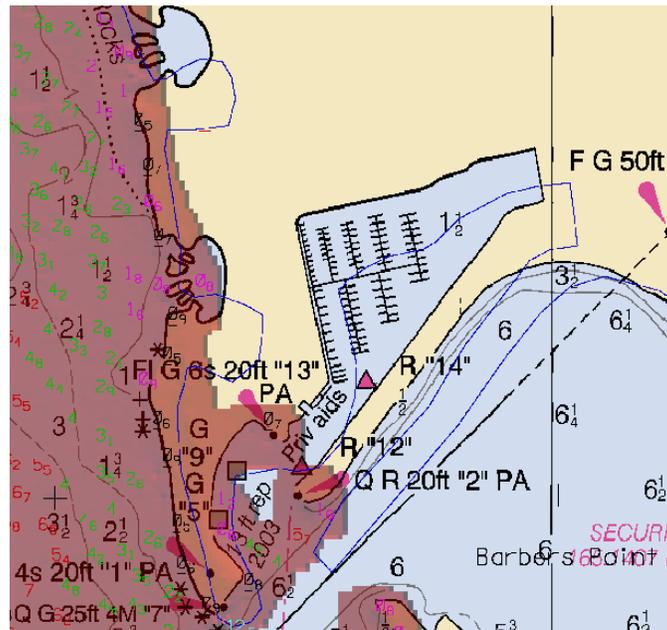
Figure 15. Offset between MHW from W00081 smooth sheet represented by the blue line and the charted (19357) coastline in Barbers Point Harbor. 19

<sup>19</sup> The source of the shoreline on the Navy smooth sheets is unknown. It is recommended that MCD use the most up to date RSD shoreline possible.

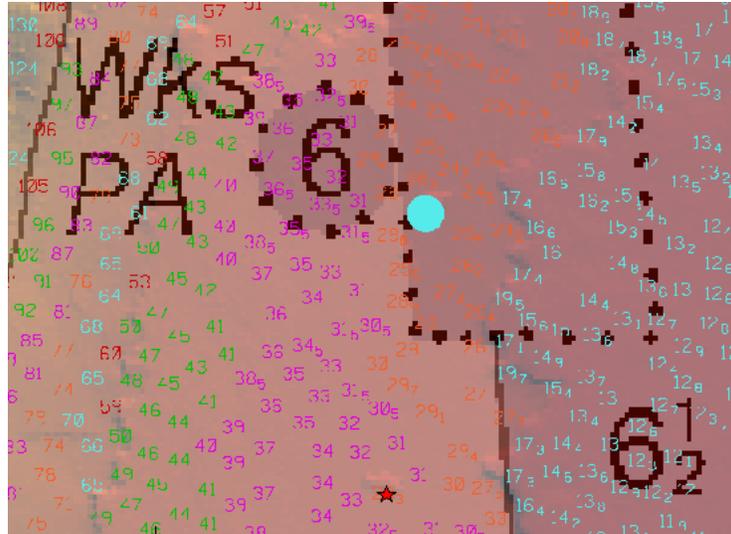
- A. The reported wreck with a least depth of 6 fm is located at 21/24/47.35 N, 158/11/44.56 W in the vicinity of a charted (19361) PA wreck (Figure 17). The surveyed wreck position should replace the charted position approximate wreck.<sup>22</sup>

**Figure 17.** The position of the surveyed wreck is represented by the blue dot in survey W00082’s smooth sheet. It is located just east of the position approximate charted wreck. The smooth sheet from survey W00082 is overlaid on chart 19357 and a transparent digital terrain model colored by depth. Smooth sheet depths are in meters.

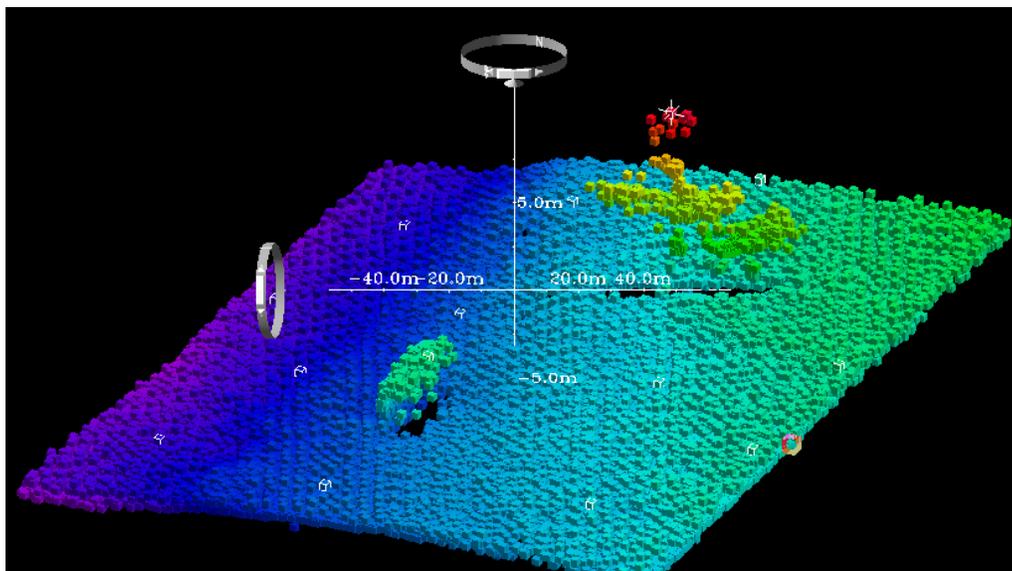
- B. This reported wreck is located in close proximity to the wreck discussed above (21/24/44.56 N, 158/11/45.77 W). Both wrecks are located inside a charted fish obstruction area (Figure 18).<sup>23</sup>

**Figure 18.** Surveyed wrecks displayed in Fledermaus 3D editor with the soundings colored by depth. These wrecks most likely represent the true position of charted (19357) position approximate wreck charted located directly to the west of the surveyed position.

<sup>23</sup> Concur with clarification; remove charted wreck PA reported 1984 on chart 19361. Chart a 14 fathom wreck at the survey position on chart 19361. This 14 wreck falls outside the Fish Haven. It is recommended that this wreck be added to the AWOIS database for future investigation.

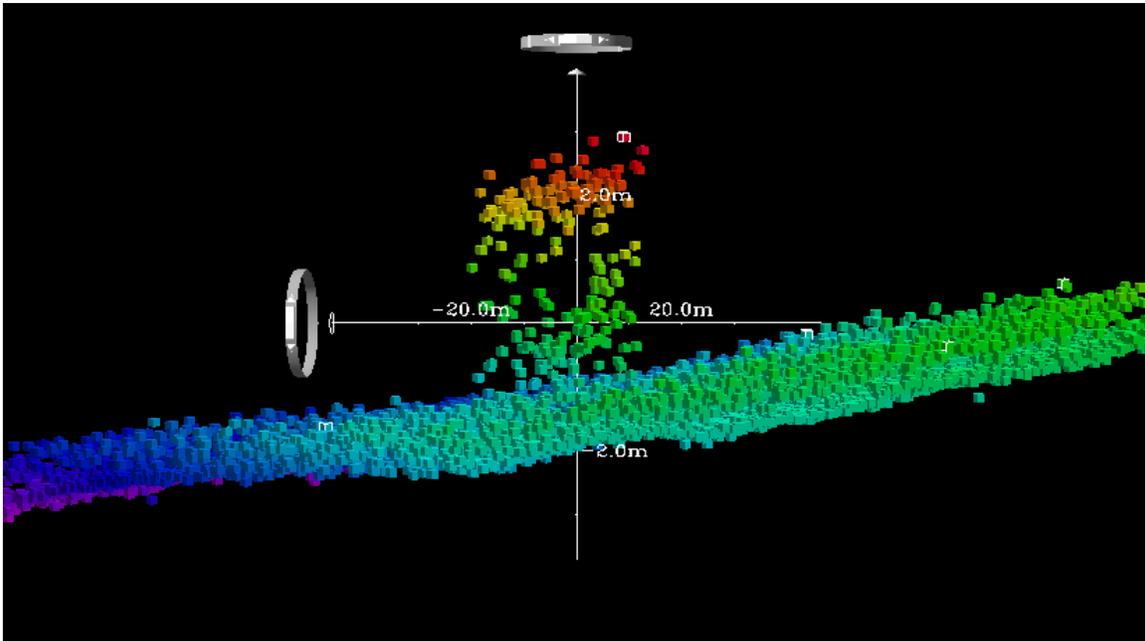
C. An obstruction with a least depth of 28.3 meters was surveyed at 21/24/32.29 N, 158/11/46.65 W (Figure 19). It is located ~250 meters south of the charted (19357) fish obstruction area. <sup>24</sup>

*Figure 19.* New obstruction displayed in Fledermaus 3D Editor with the soundings colored by depth.

- 
- <sup>24</sup> Concur, chart 15 fathom obstruction at the survey position on chart 19361. It is recommended that this obstruction be added to the AWOIS database for future investigation.

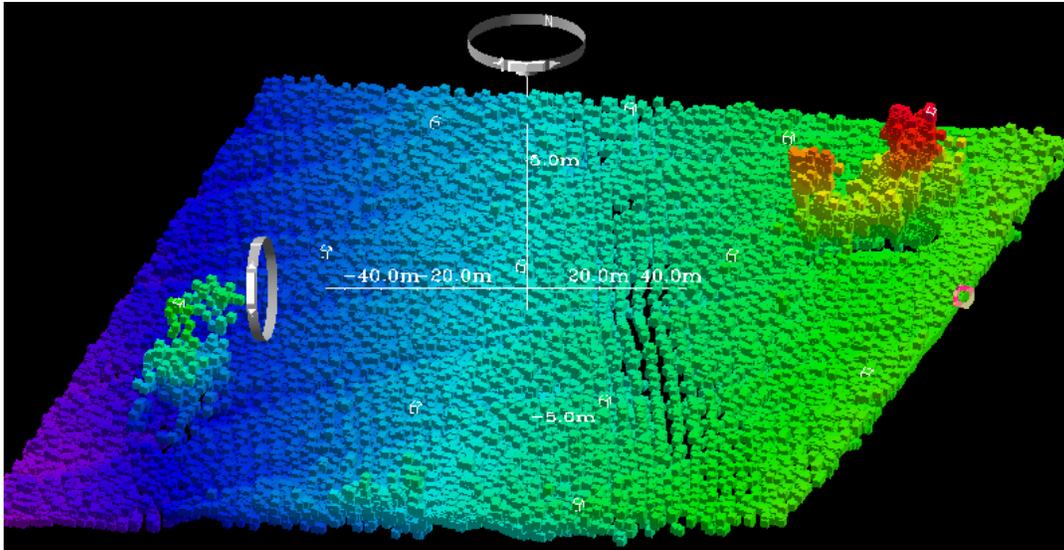
- A. A charted (19357) wreck was confirmed by surveyed data at a position of 21°25'11.15" N, 158°11'40.82" W. The wreck is located inside a charted fish haven and is located in close proximity to the additional wrecks and obstructions reported by NAVOCEANO (Figure 20). <sup>25</sup>
- B. A wreck was reported at 21°25'14.62" N, 158°11'35.3" W with a least depth of 19 meters. It was confirmed by the Reviewer in Fledermaus 3D Editor in the vicinity of the wreck noted above, also located within the limits of the charted fish haven (Figure 21). <sup>26</sup>

Figure 21. Surveyed wrecks A and B shown in Fledermaus 3D Editor with soundings colored by depth.

- <sup>26</sup> Remove charted wreck Rep 2000 PA at latitude 21/25/11.1N, longitude 158/11/33.9W. Chart a 10 fathom wreck according to this survey.
- <sup>27</sup> These pinnacles are not recommended for charting because they are within the charted Fish Haven and the Fish Haven has a authorized minimum depth of 6 ¾ fathoms.

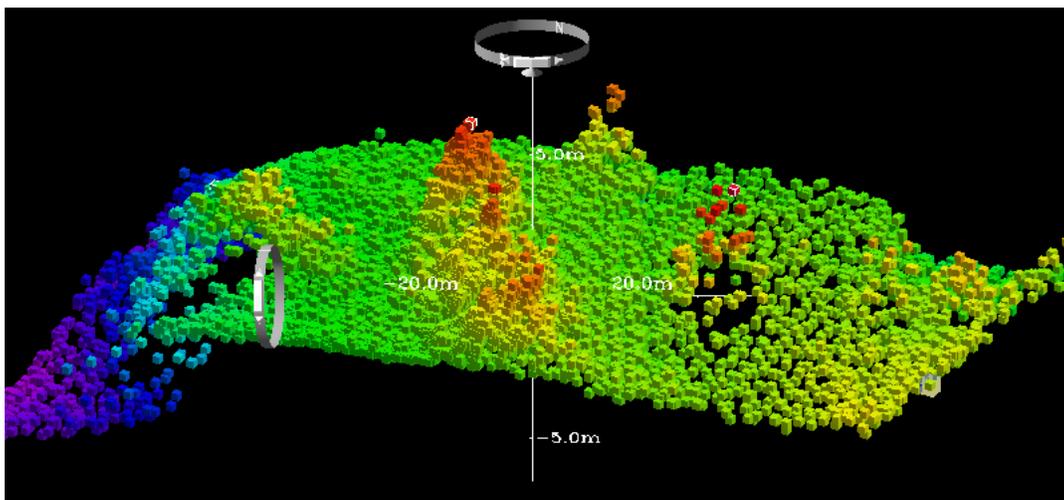
C. Four pinnacles were reported by NAVOCEANO located in the vicinity of 21/25/07 N, 158/11/34 W with a least depth of 15.5 meters (Figure 22). The pinnacles are also located within the charted fish pen limits.<sup>27</sup>

Figure 22. Geologic Pinnacles reported by NAVOCEANO displayed in Fledermaus 3D-Editor. Soundings are colored by depth.

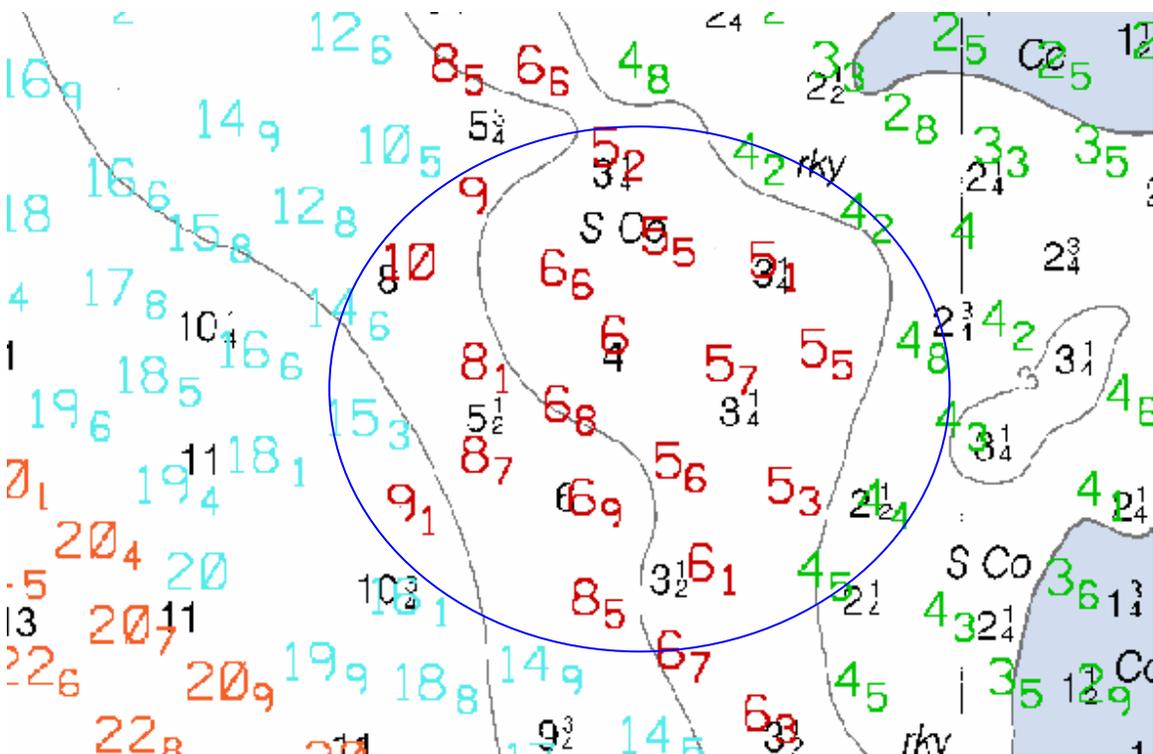
D. The charted bounds of the coastal reef have expanded seaward in the vicinity of 21°27'40.77 N, 158°13'10.32 W. A 5-fathom (9.1 m) sounding was surveyed seaward of the charted 10fm contour (Figure 23). It is recommended that the 5 and 10 fm contours be updated to reflect the surveyed changes.<sup>28</sup>

**Figure 23.** W00083 smooth sheet overlaid on chart 19361. A 9.1 meter (5 fm) sounding was surveyed seaward of a charted 10-fm contour representing the expansion of the reef seaward.

- <sup>28</sup> Concur
- <sup>29</sup> Retain charted note at lat. 21/25/52.7N, long. 158/12/25.5W.
- <sup>30</sup> Chart according to the smooth sheet.
- <sup>31</sup> The source of the shoreline on the Navy smooth sheets is unknown. It is recommended that MCD use the most up to date RSD shoreline.

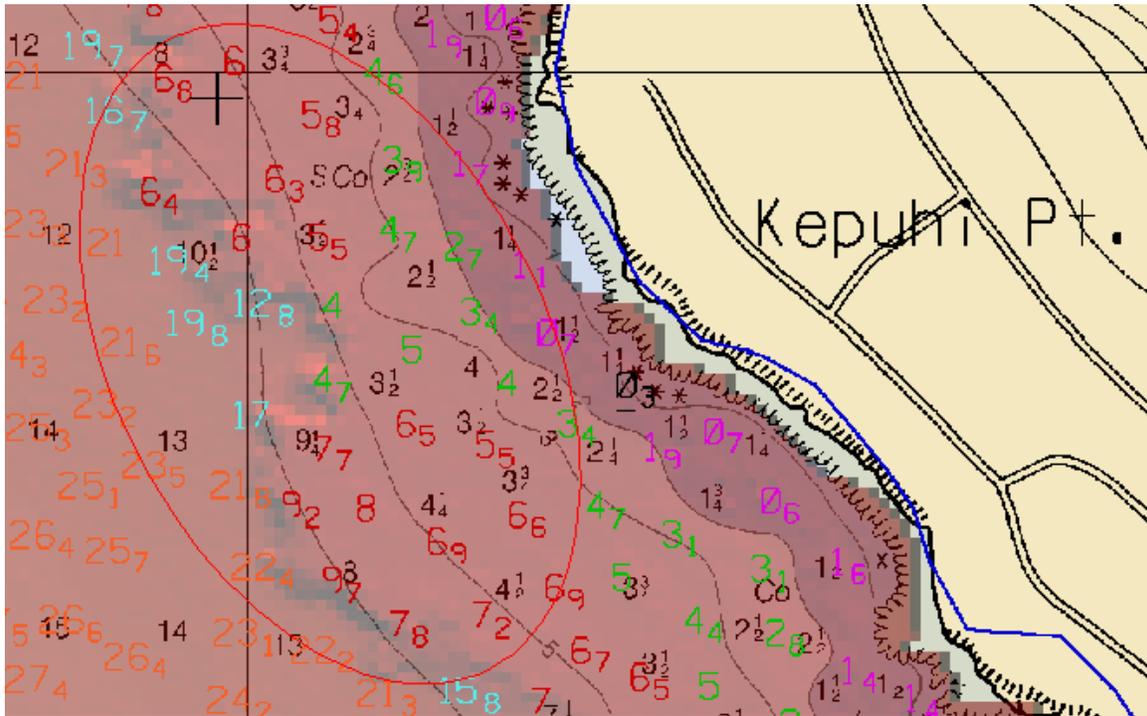
B. A 2.56 fm (4.7m) sounding located at 21/28/54 N, 158/13/57 W in the vicinity of a charted 5-fm contour (Figure 25).<sup>33</sup>

**Figure 25.** W00091 smooth sheet overlaid on chart 19361 and a digital terrain model colored by depth. Smooth sheet soundings in meters. New shoaling observed in vicinity of 5 and 10 fathom charted contours. The reef has expanded seaward.

The 5 and 10 fathom contours definitely need to be updated to reflect the expansion of the reef.<sup>34</sup>

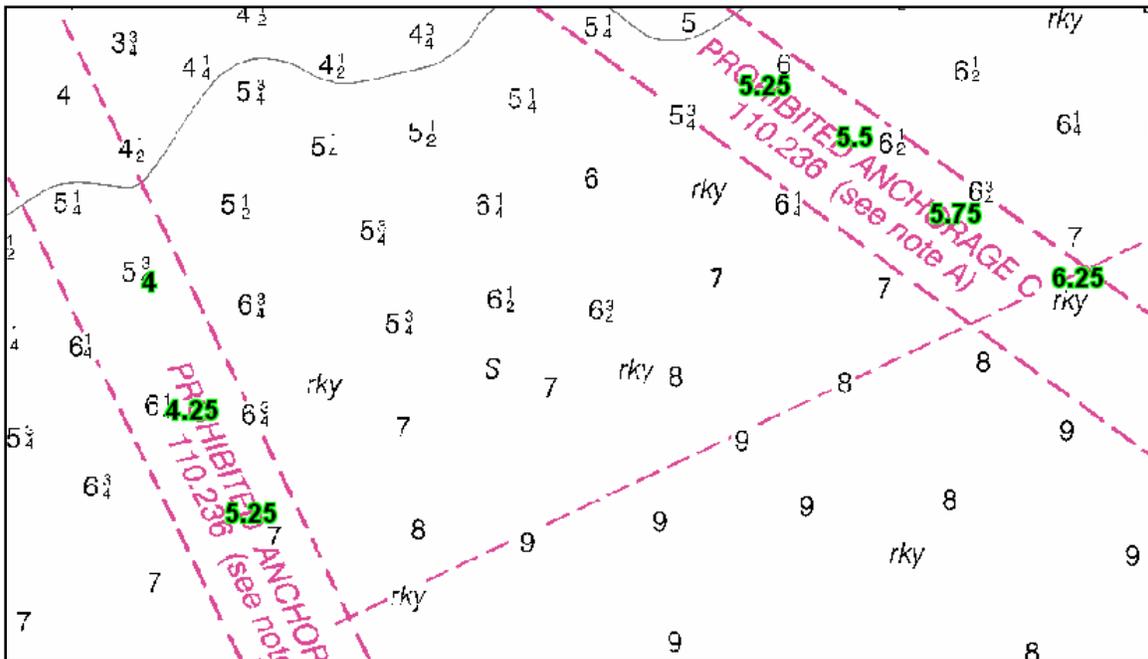
Seven dangers to navigation (DTON) were found during review of survey W00079 submitted by the U.S. Naval Oceanographic Office.

The DTONs are located south of Kalaeloa in charted (19362) Prohibited Anchorage Areas B and C. The Prohibited Anchorage Areas represent the boundaries surrounding submerged pipelines noted in the current Coast Pilot. The selected DTON soundings are significantly shallower than charted depths over the pipeline.

**Figure 1.** A chartlet depicting the location of the dangers to navigation reported for Survey W00079 with NOAA Chart 19362 as the background. The DTONs are displayed as black soundings highlighted in green. Soundings are in fathoms.

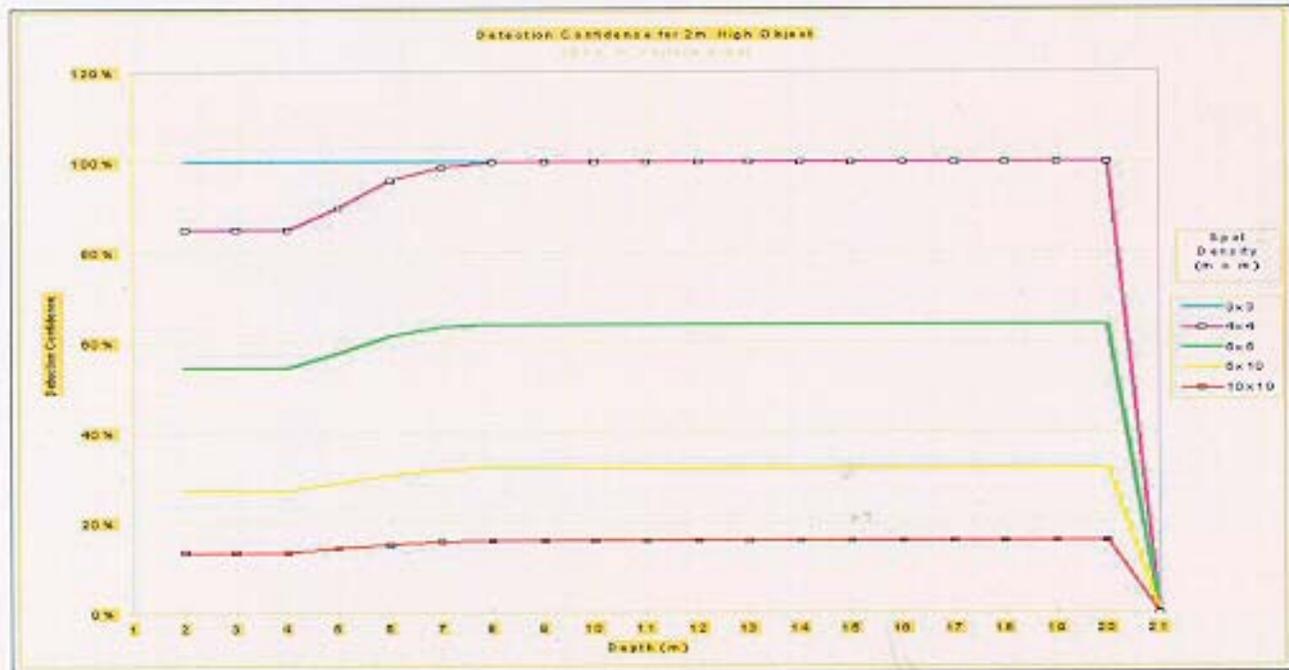
Figure 1. Target detection confidence

1.4.5 Subsequent testing of the follow-on CHARTS system, utilizing the same operating principles and algorithms and a lower power laser at 4x4 spot spacing, targets of 2 meters were detected 100% of the time in depths of 5 to 30 meters. Based on these actual tests the LIDAR system meets IHO Order 1 target detection requirements. Multiple coverage provides a degree of redundancy for this capability.

Theoretical detection confidence vs. depth for a 2m target at different laser spot densities.

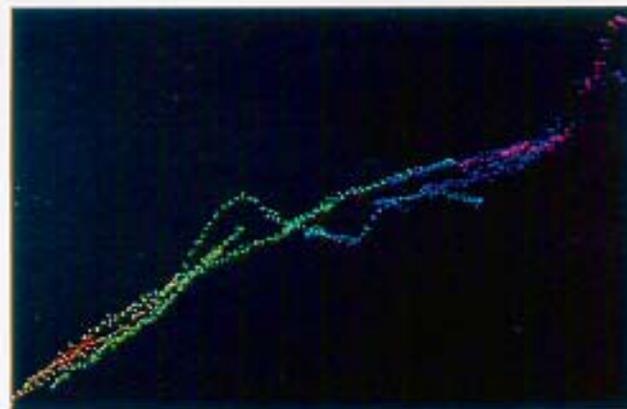
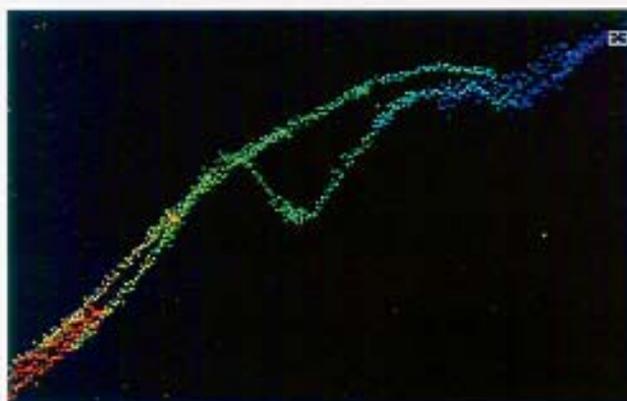
Figure 8. Series of near shore seabed to beach profiles from the area of Barking Sands, Kauai depicted in Figure 7. Insets a-d are west to east cross sections. Inset e is from the north east to southwest along the full length of the near shore.
